DInSAR applications for deformation monitoring

Delia Teleaga¹, Valentin Poncos¹, Juerg Lichtenegger²

¹Advanced Studies and Research Center (ASRC), Bucharest, Romania

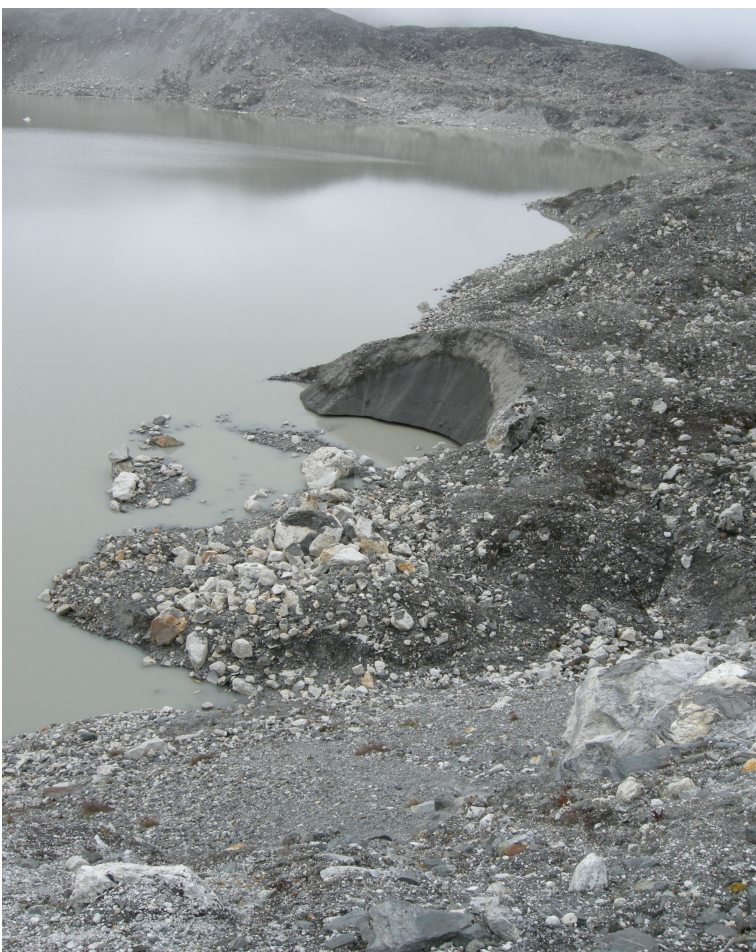
Ice covered by ground moraines at the western end of the lake. This part also shows a movement in the interferogram probably due to the melting process. It could result in a lowering of the terrain and hence a rapid lowering of the lake level.

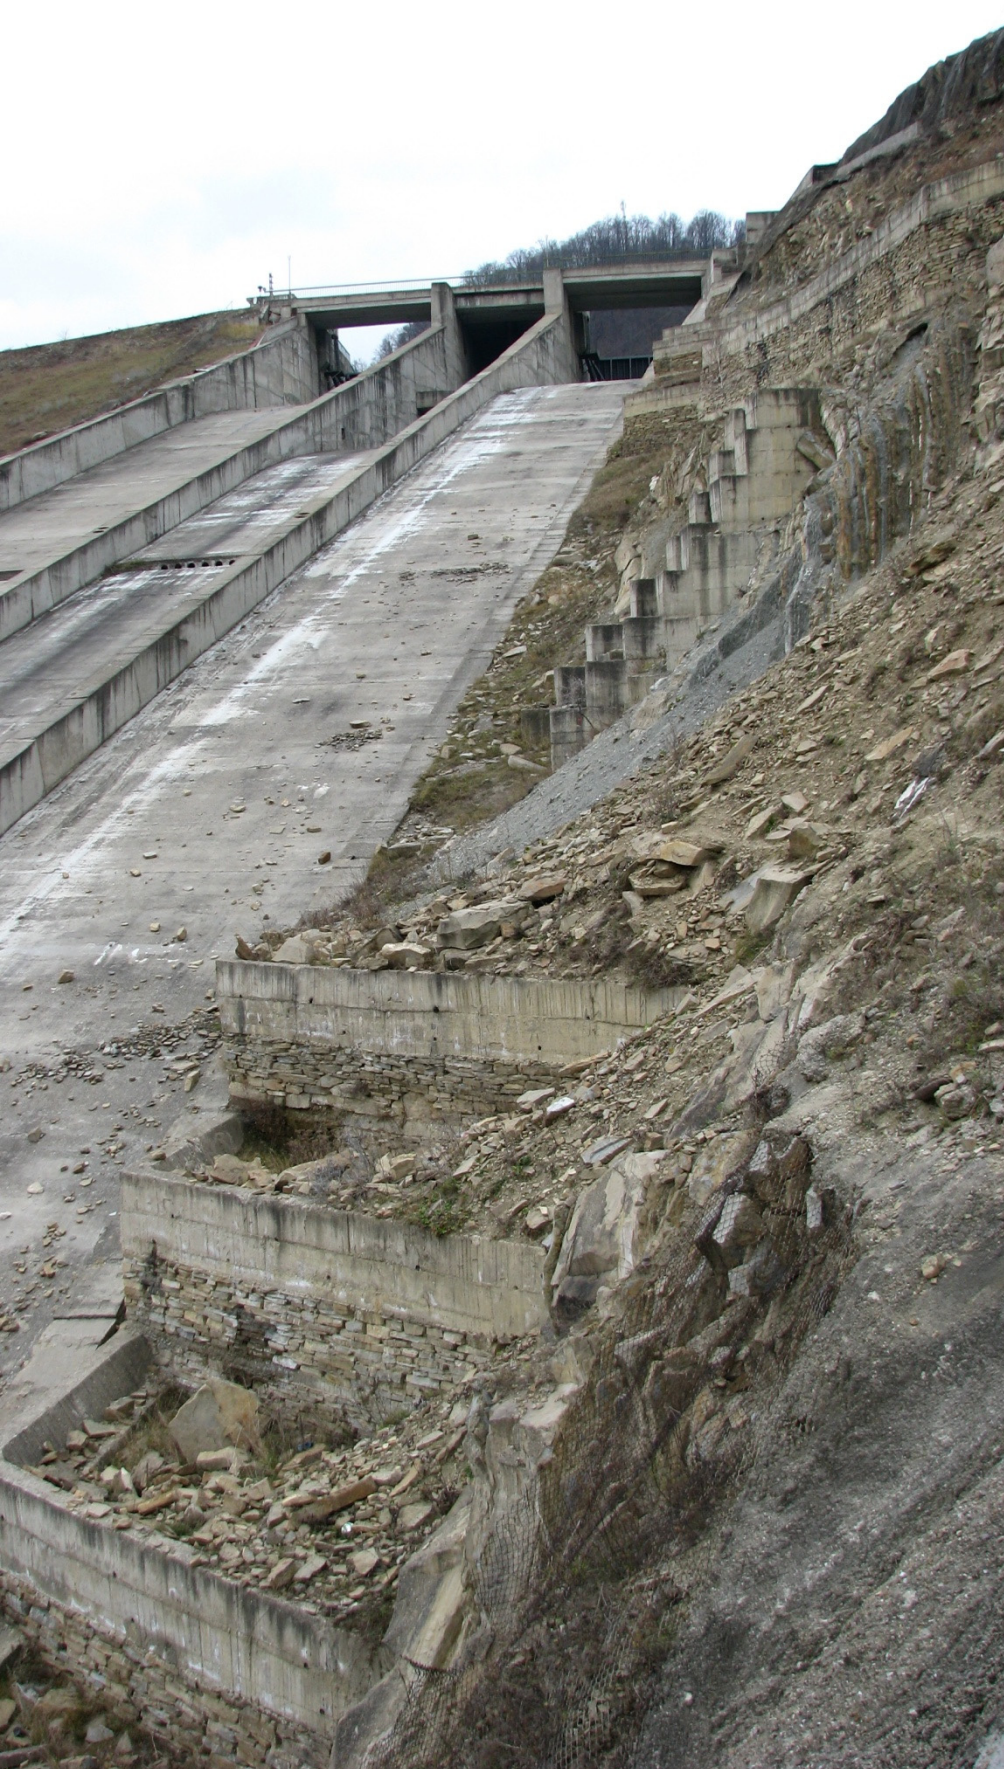
Deformation of the waterdam infrastructure due to the slopes instability

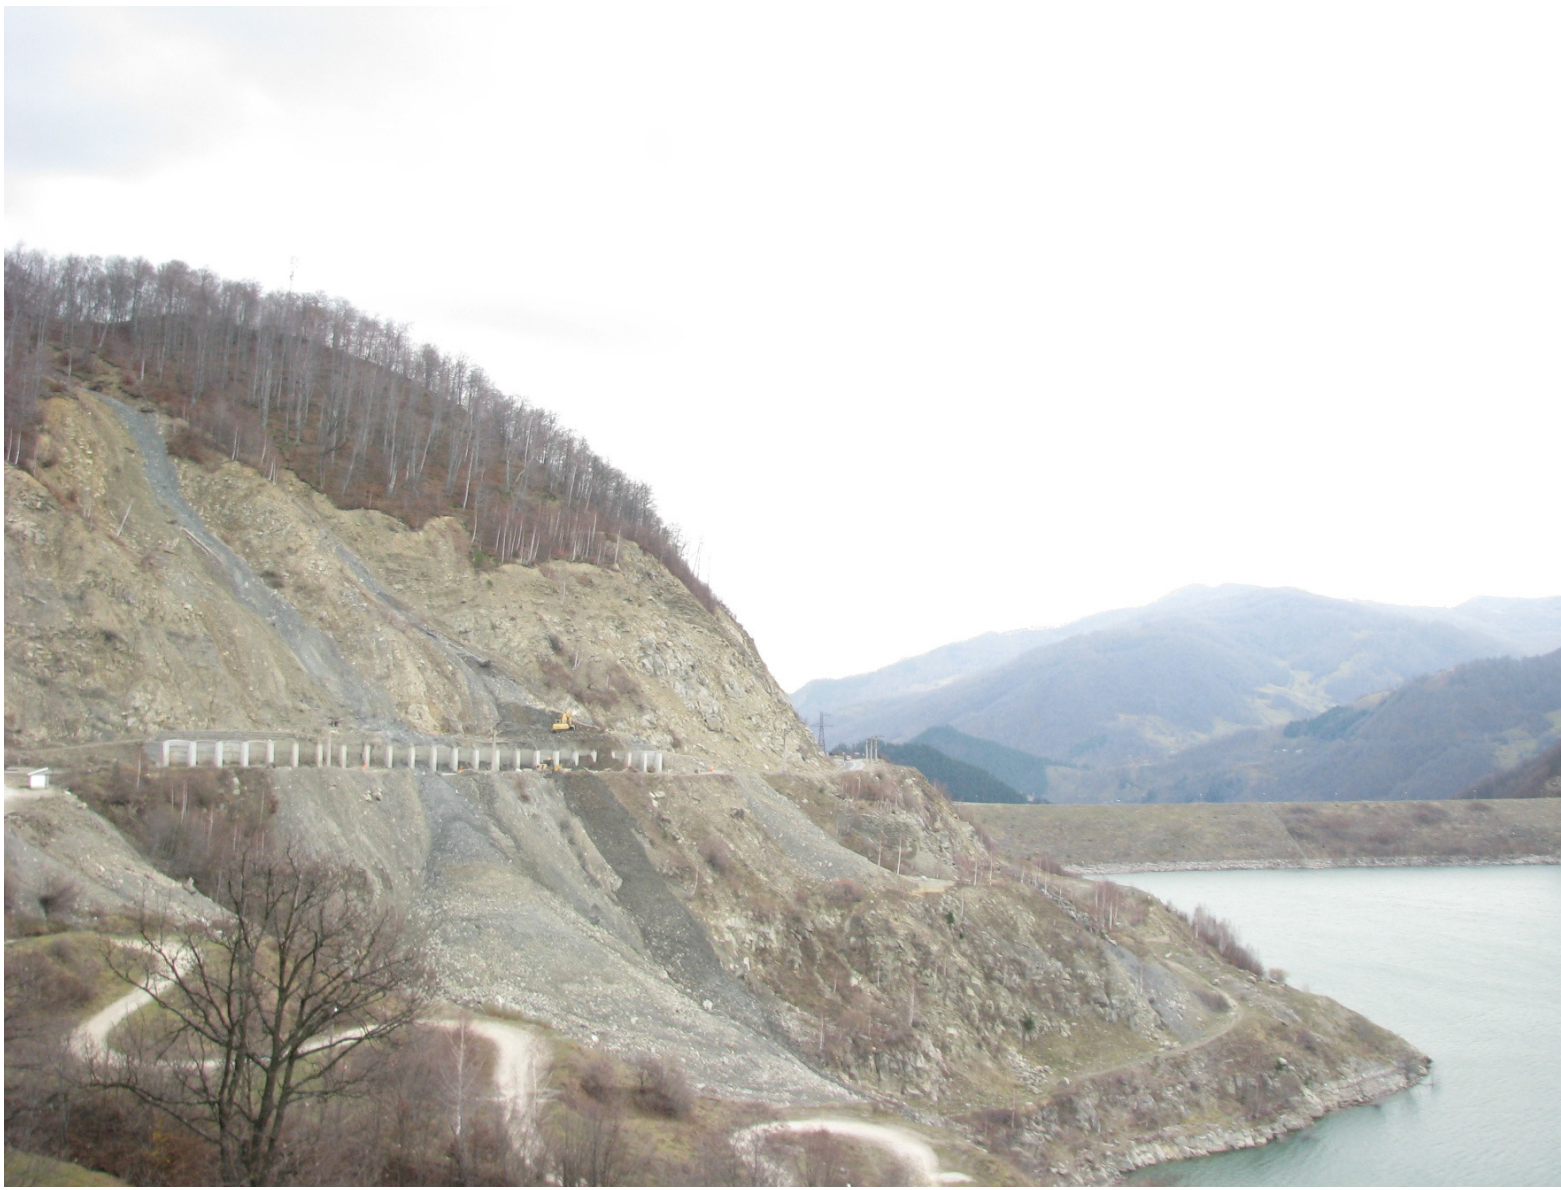
Road affected by a landslide. It can be seen as coherent on the deformation map, except the two new landslides (gray) that occurred in between the acquisition dates. According with the InSAR measurements, the left side of the landslide is stable, the middle part (between the new flows) is moving slightly, while the right side is very instable, moving with 2 cm in 11 days.
